# Compressive testing of TRAFFIC-LINE Cable Protection Ramp

Mr Jonathan Pert, MORAVIA (UK) Ltd, Unit 9+10 Spring Mill Industrial Estate, Avening Road, Nailsworth, Gloucestershire, GL6 OBS

**Job No:** D5292

**Date:** 19/07/2013 **Prepared by:** Mr N Kenworthy

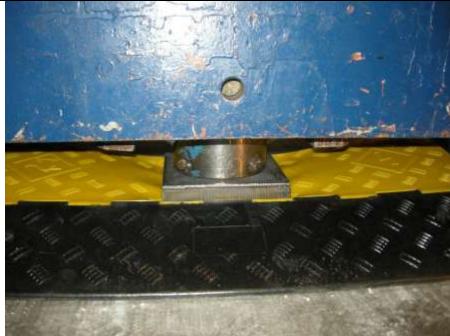
**Photo 1:** Image shows sample 1 under a load of 5 tonne proof load. Sample can be seen to have compressed to some extent under the load. Slight bowing of lid at ends of samples evident. This image is representative of all samples at this point of the test.

The product performed well up to the 5 Tonne proof load point but some flexural deformation of the product did occur at loads in excess of 2.5 Tonne.

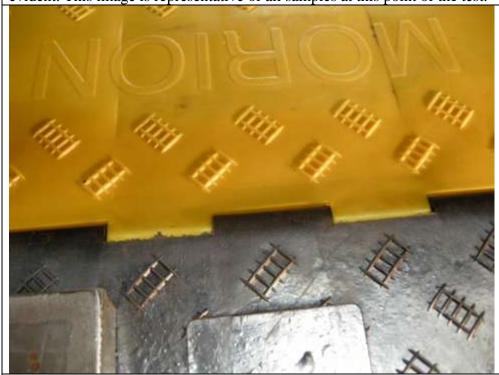
**Photo 2:** Image shows sample 1 after being loaded to 5 tonnes and is typical of all 3 samples. Notice slight indentations left by the steel plate, under normal conditions the load is applied via a lorry tyre so it is unlikely that this deformation will occur in service. Also notice that no damage has occurred to the hinges at this stage.

Application of the proof load with a steel plate is a relatively simple test but it may not be representative of the load application in service. In service the load will be predominantly applied by a tyre and hence will tend to spread the stress at the edges of the loading. For this reason the testing performed in this work may represent the worst case scenario. A more rounded profile or steel plate covered with a tyre would probably not result in a permanent deformation mark.

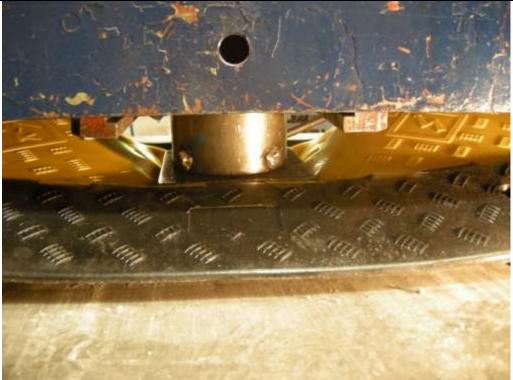
**Photo 3:** Image shows sample 2 under a load of 17 tonnes and is representative of all samples. Notice significant compression of sample and lifting of the ends is evident.

At loads above 14 Tonne the load rate increases significantly and hence is probably due to compression of the rubber substrate (black rubber moulding). Hence it is probably not realistic to consider loads in excess of this figure.

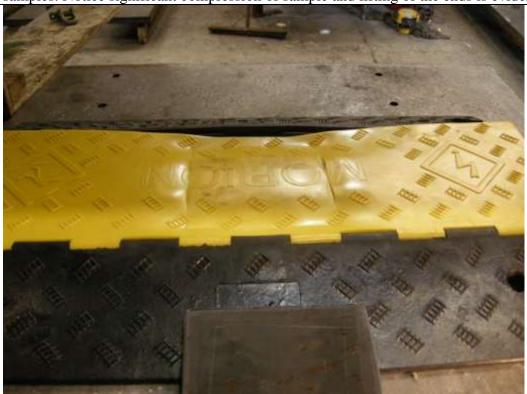
**Photo 4:** Image shows permanent deformation of lid to sample 1 caused by the load of 17 tonnes and is representative of other samples. Notice that hinges are still intact.

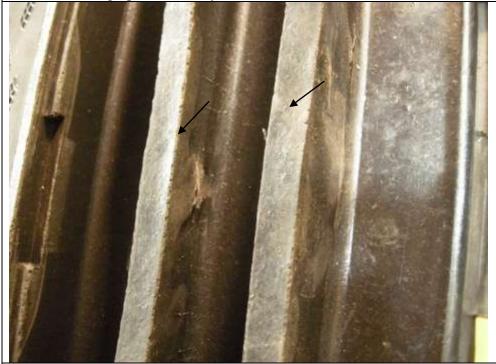
**Photo 5:** Image shows deformation and splitting observed in the base of sample 1 directly underneath the point of load after application of 17 tonne load and is also representative of the damage found to sample 3.

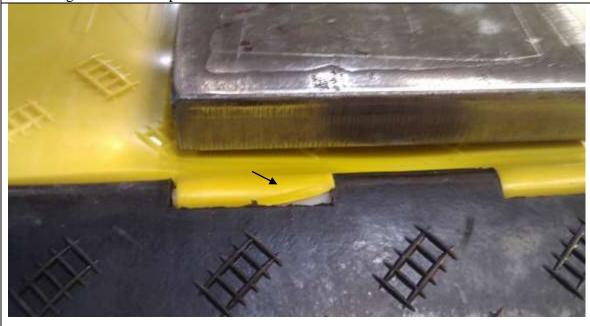
**Photo 6:** Image shows crack to hinge that occurred in sample 2 during loading to 17 tonnes. This damage was only evident in this sample, no damage to hinges was observed in other samples. It should also be noted that the cracking occurred at greater than 14 tonnes, well in excess of the 5 Tonne proof load.

One sample did show cracking of the hinge at the higher loads and this appears to have split at the weak point in the hinge i.e. the seam line of the plastic.
